Port Reading Daylighting by Tank 1216 Field Summary

February 24, 2021

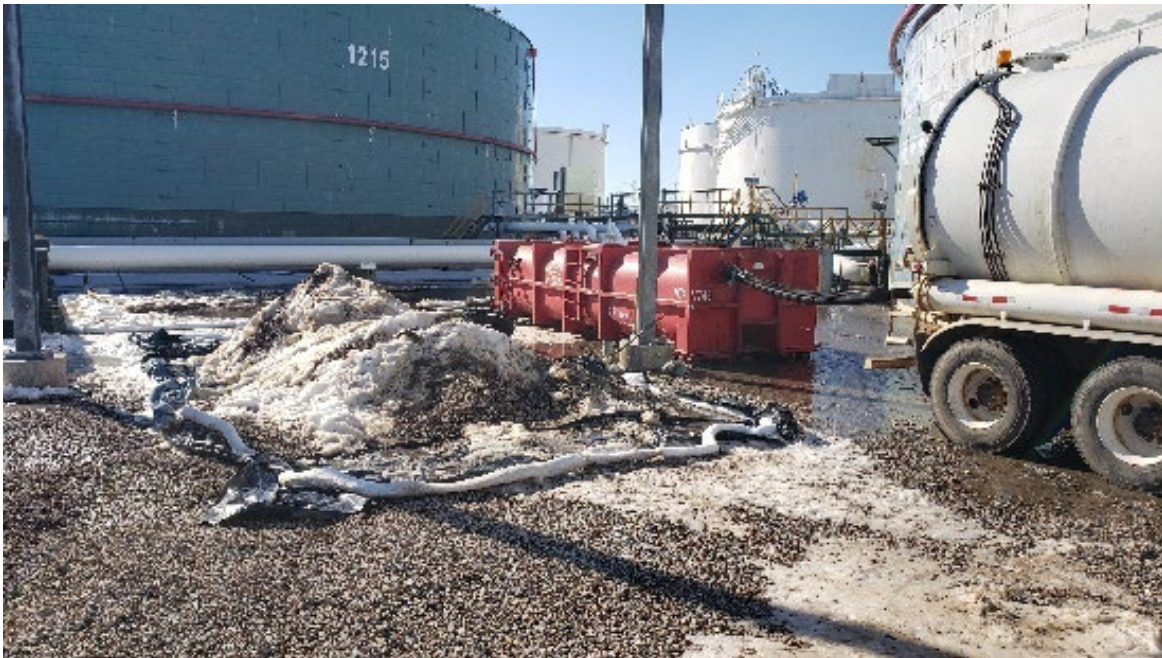
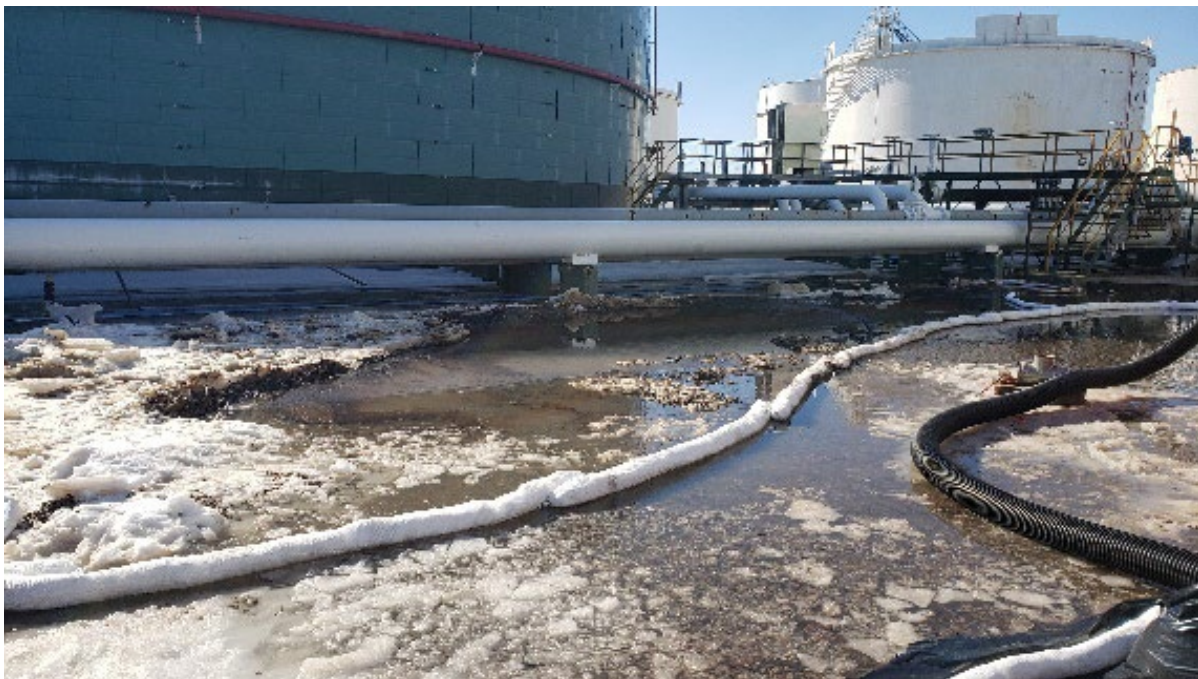
- Earth Systems arrived on-site at 1430 to investigate and document any daylighting or staining in the third tank field.
- Two different types of product were observed – a more liquid product and a product with thicker consistency. Samples of both types of product were collected for fingerprint analysis.
- Clean up initiated by Buckeye.
- A 25 cubic yard tank and vac truck setup and absorbent booms were observed and can be seen in the photographs below.
- Plastic sheeting staged with snow and gravel debris containing possible contamination was also observed and can be seen in the photographs below.
- Absorbent booms were being used to contain product impacted area.
- Atlantic Response employees arrived on-site at 1530 to drop off a trailer-mounted pump and told Earth Systems employee they would resume vacuum activities February 25th; see photographs below.

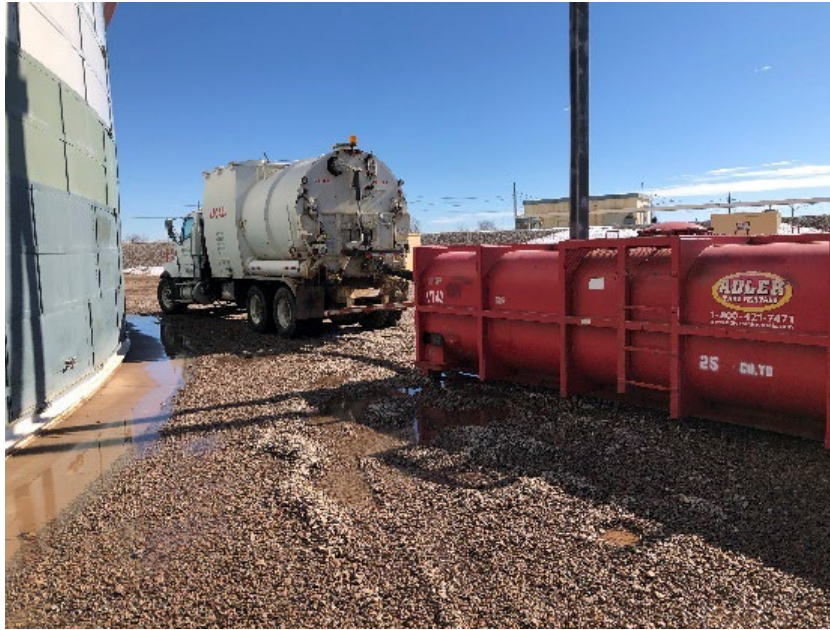
- Photographs below display 25 cubic yard tank and vac truck setup and tanker footing.
- 1450 Earth Systems off-site

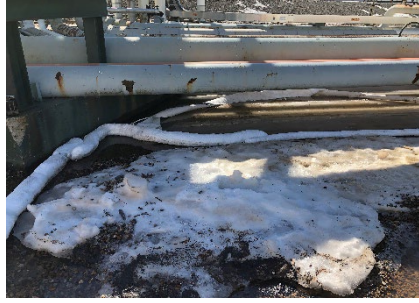
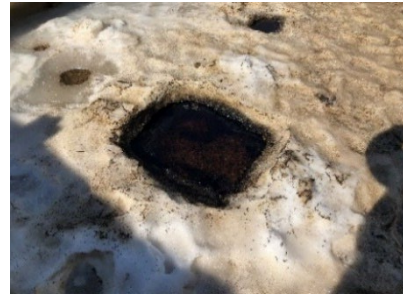
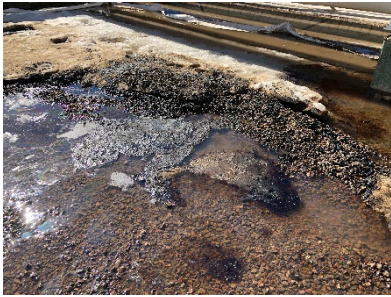
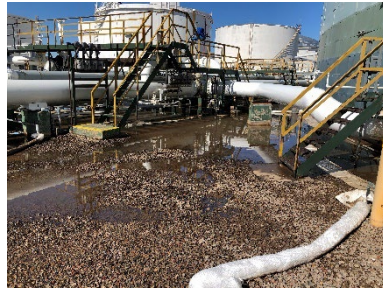
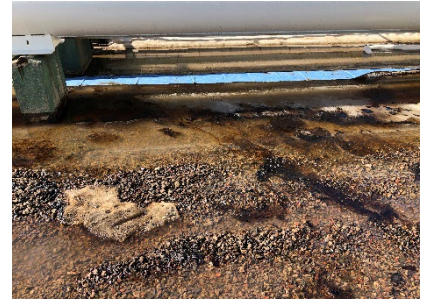
- Photographs below display conditions when Earth Systems arrived (areas of staining and boom placement)

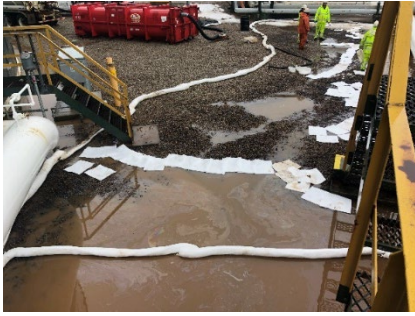
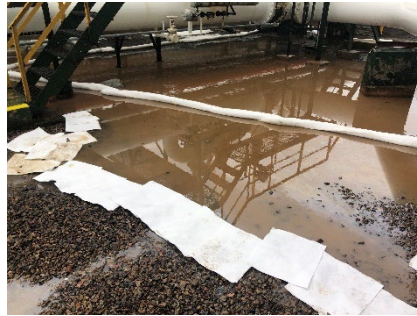
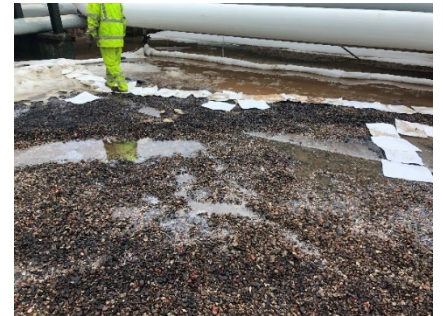
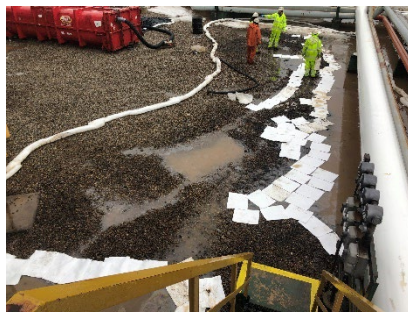
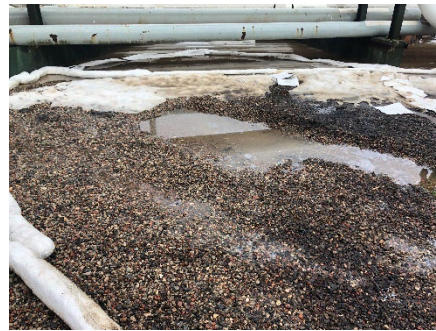
- 0800 Earth Systems on-site to inspect the third tank field area. Based on the photographs below and discussion with Earth Systems employees, it was determined that AWT would be needed to replace current booms. Photographs below display absorbent booms and pads being replaced.
- AWT replaced booms along the perimeter of the area of concern. AWT also used absorbent pads to address any visible product. AWT used five (5) packs of spill booms, two (2) packs of pads, and three (3) drums.
- 1450 Earth Systems off-site.

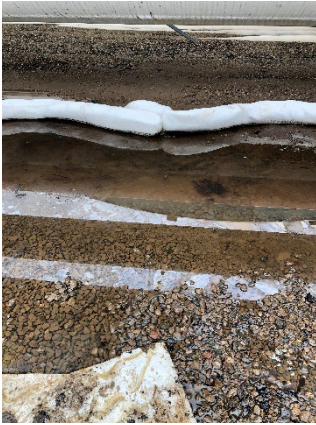
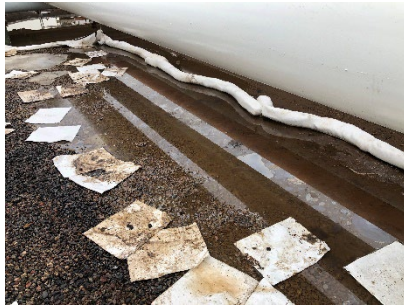
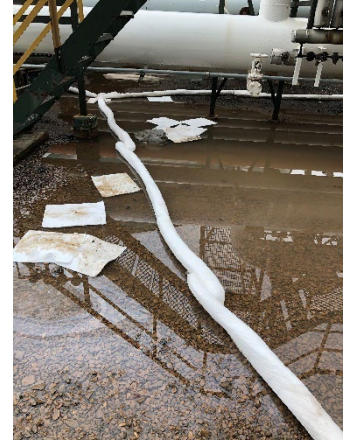
- Earth Systems arrived on-site at 0800 to inspect the daylighting area.
- Booms showed no signs of over saturation or failure to maintain containment of sheen and product.
- Earth Systems replaced pads as well as removed some visual surficial product using absorbent pads and placed in a drum for offsite disposal.
- Earth Systems was off-site at 0930.
